## SUMMARY

1234 Main Street FL

James Kupiec  
Royalty Inspections, Inc  
+14075586212  
jkupiec0222@gmail.com

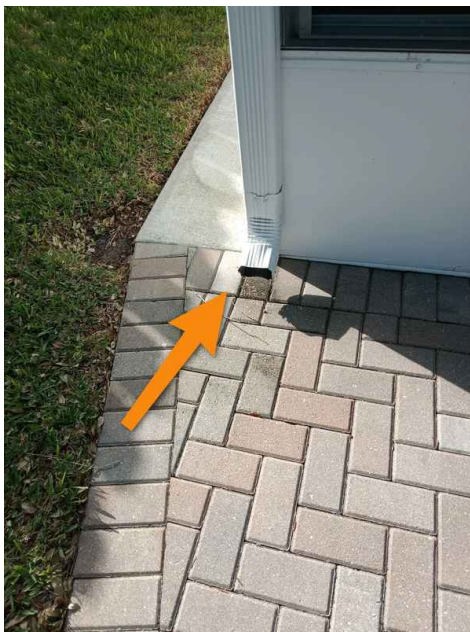
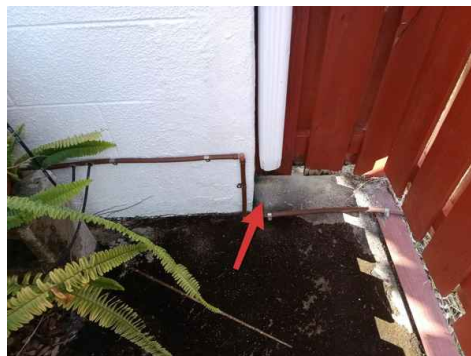
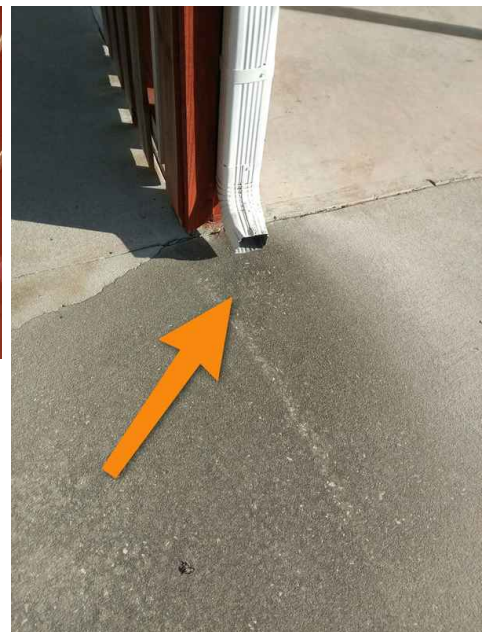
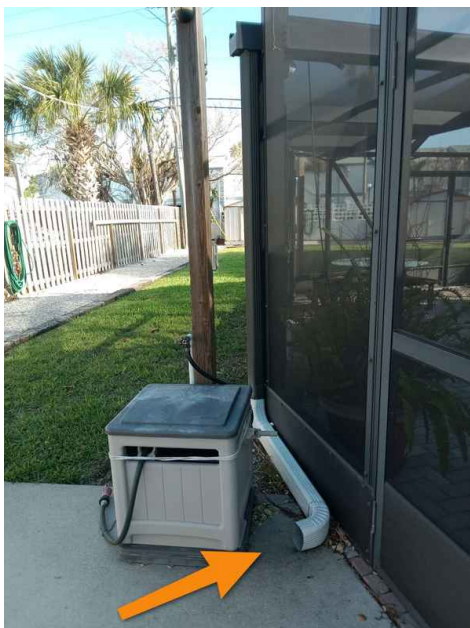
#### DOWNSPOUTS W/O EXTENSIONS - DRAIN NEAR HOUSE

One or more downspouts drain too close to the home's foundation. This can result in excessive moisture in the soil at the foundation, which can lead to foundation/structural movement. Recommend a qualified contractor adjust downspout extensions to drain at least 6 feet from the foundation.

Gutter Downspout w/o Extension

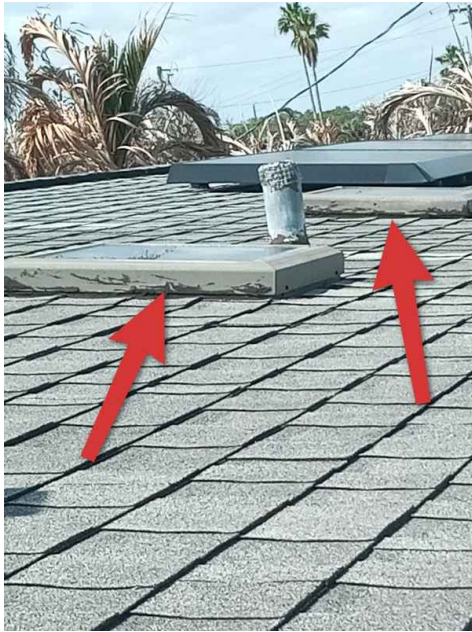
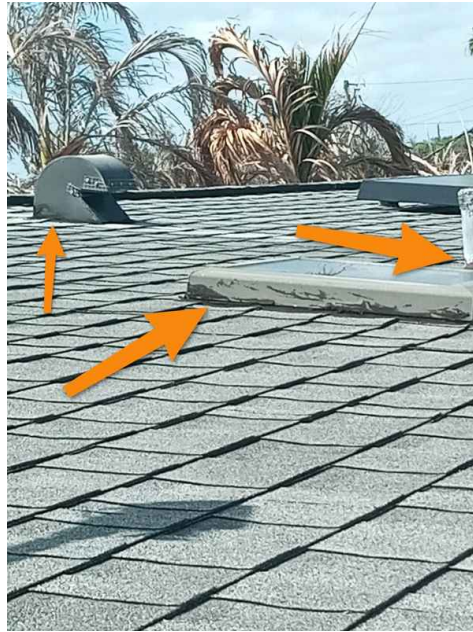
**SKYLIGHT WATER PENETRATION**

There are signs that the flashing materia at or near the skylights and exhaust vents are in need of restoration. Recommend a qualified roofing contractor evaluate to prevent future leakage.

Skylight / Vent Flashing

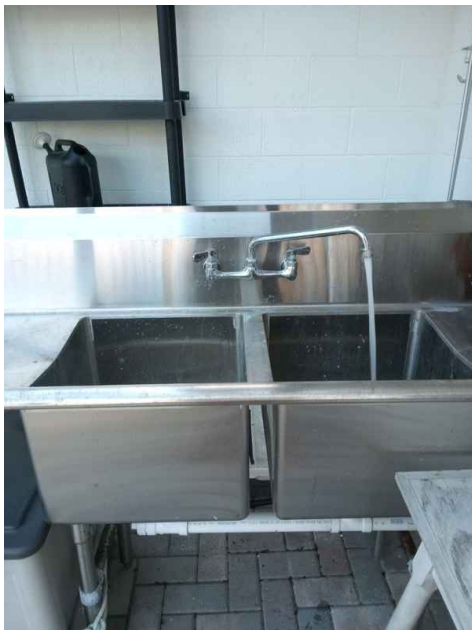
The right side drain in the stainless steel sink was leaking due to a crack in the drain pipe. Recommend a qualified plumber evaluate and repair.

Outside Sink - Screen Enclosure

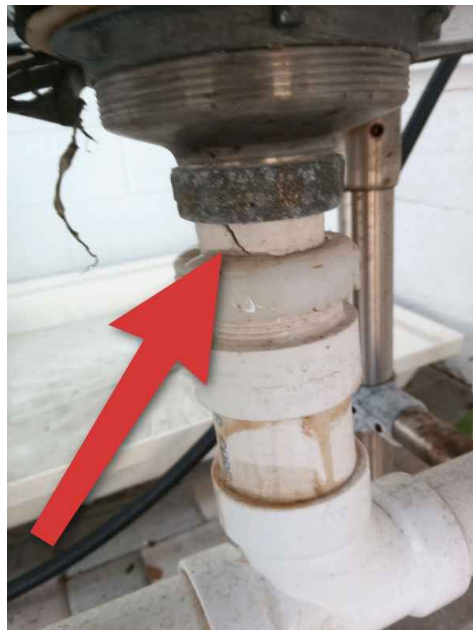
**LEAKING PIPE**

Crack in Pipe - Under Right Sink

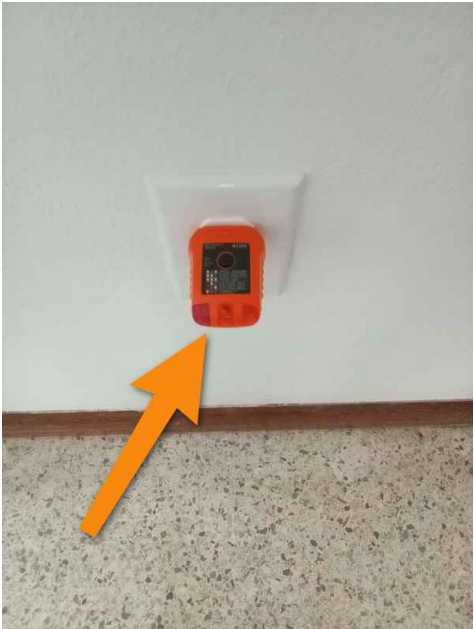
**INOPERABLE RECEPTACLE**

Receptacle nearest front entry door is not operable. Recommend a qualified contractor evaluate.

Inoperable Receptacle - Nearest Front Entry Door

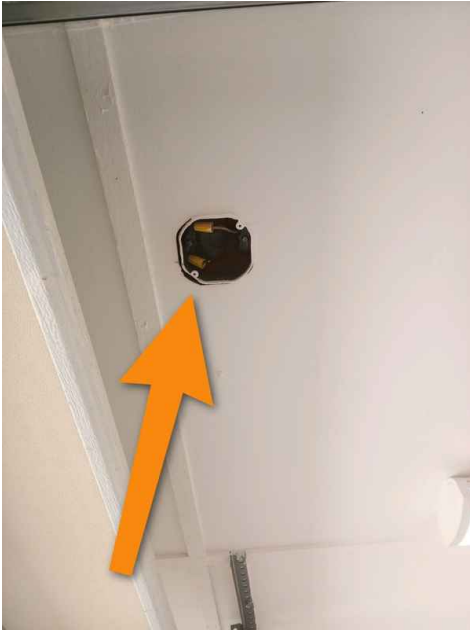
**COVER PLATE MISSING**

Cover plate of receptacle garage ceiling missing.

Missing Cover Plate - Receptacle Garage Ceiling

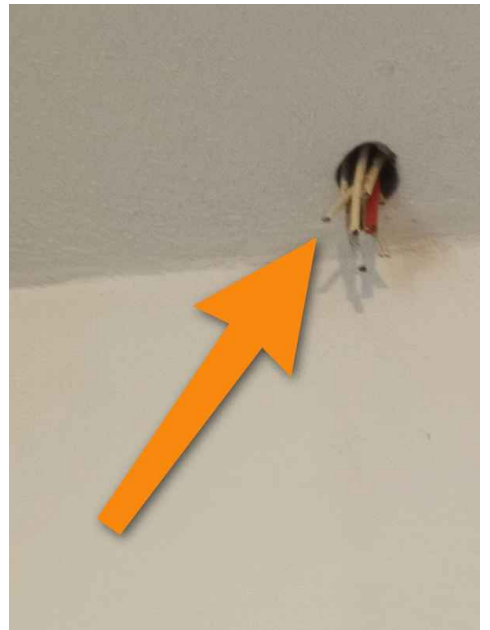
##### **LOW VOLTAGE WIRES EXPOSED**

Low voltage wires exposed near water heater in laundry room.  
Recommend a qualified contractor evaluate.

Low Voltage Wires Exposed - Laundry Room
